Bolingbroke Castle

How was the moat restored?

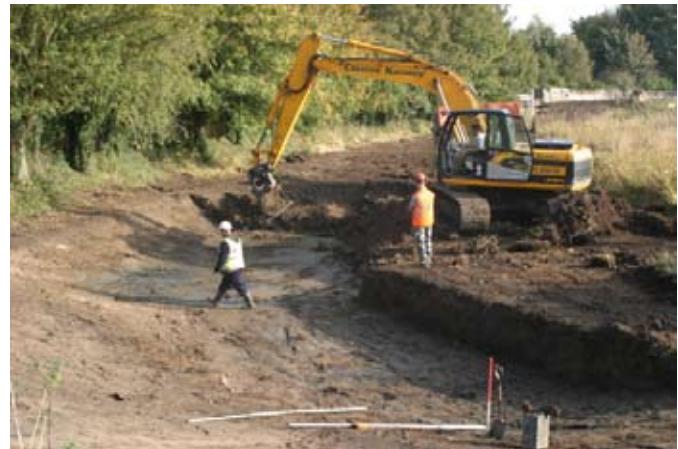
The moat was restored by digging out the silt and dead plant remains that had gradually built up over the past 40 years. A large excavating machine was used to do the digging and big tracked dumpers transported the silt that was removed to the rout yard where it was spread inside the rectangular earthwork there.

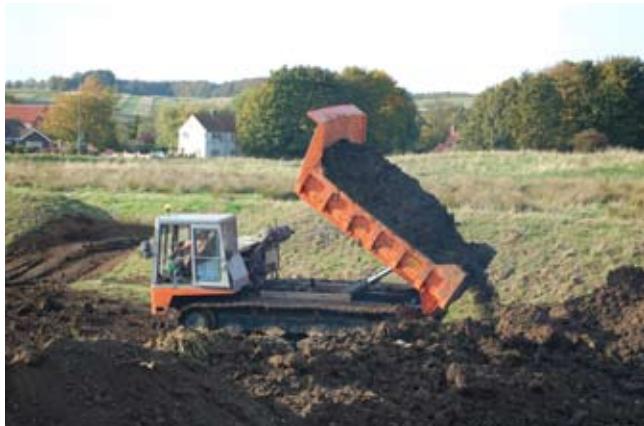
Removing all this material was a major undertaking which took nearly a week to complete. However, because the castle is such an important site the work had to be very carefully planned to avoid damaging either the archaeology or the wildlife that is there, and special permission had to be obtained before it could be carried out.
