Pinnacle rebuild at Lincoln Cathedral

As part of the North East transept project at Lincoln Cathedral, which saw a host of conservation works, cleaning, glazing and stone replacing, I was lucky enough to be able to assist 2 experienced masons in the rebuilding of an entire pinnacle.

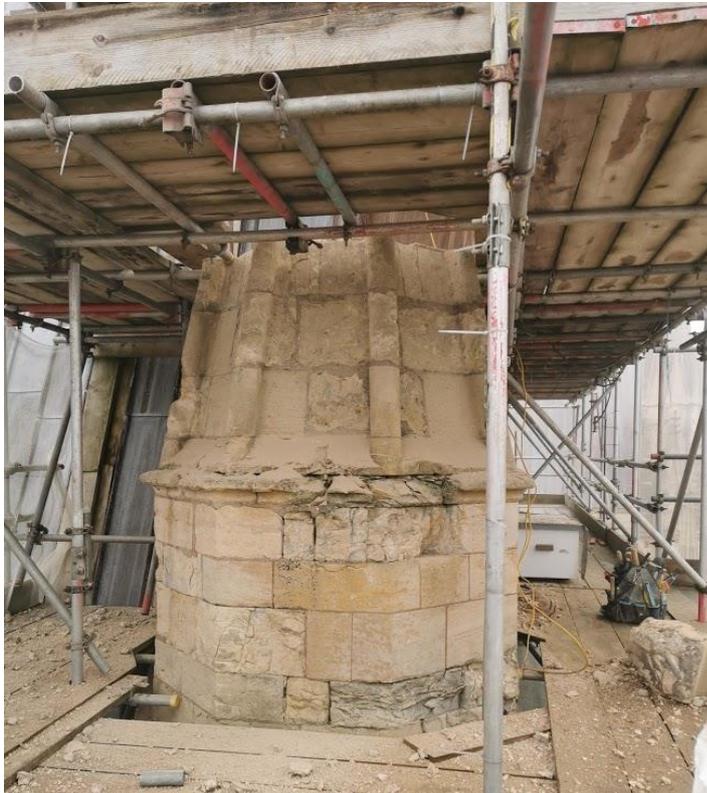
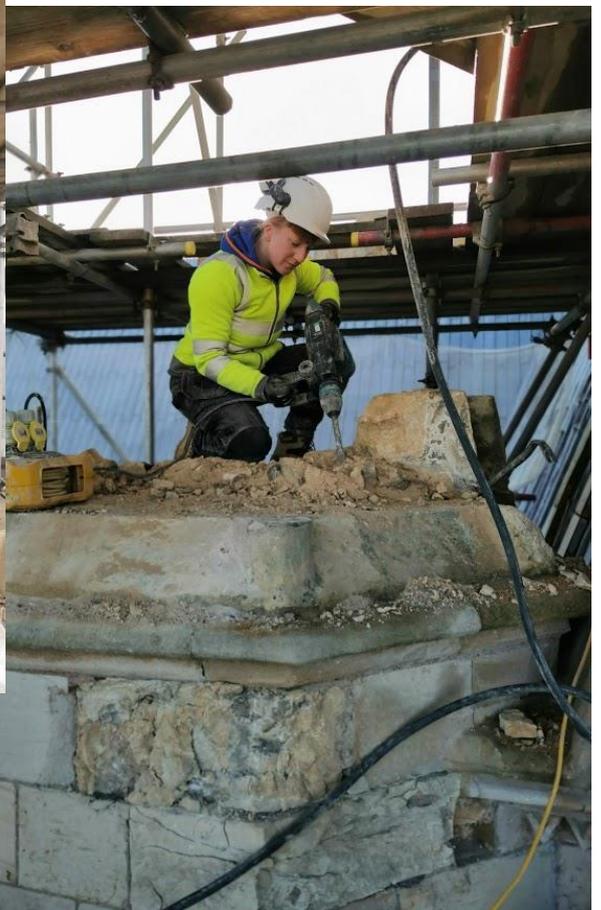
This particular pinnacle on the North East Transept is a part of the building originally constructed in the 14th century, however upon closer inspection of the pinnacle some of the original medieval stone had already been replaced with a different stone type possibly in the victorian era when a lot of restoration work was done with cement which can ultimately cause major structural damage.

As you can see from the photographs below the stone was delaminating, and crumbling away, the damage became even more apparent as we were dismantling it.

Large rebuilds like this don't happen very often; working on a heritage building the top priority is always to save as much original fabric as possible, so as masons we were particularly excited about the opportunity to rebuild a full structure like a pinnacle, which had become structurally unsound.

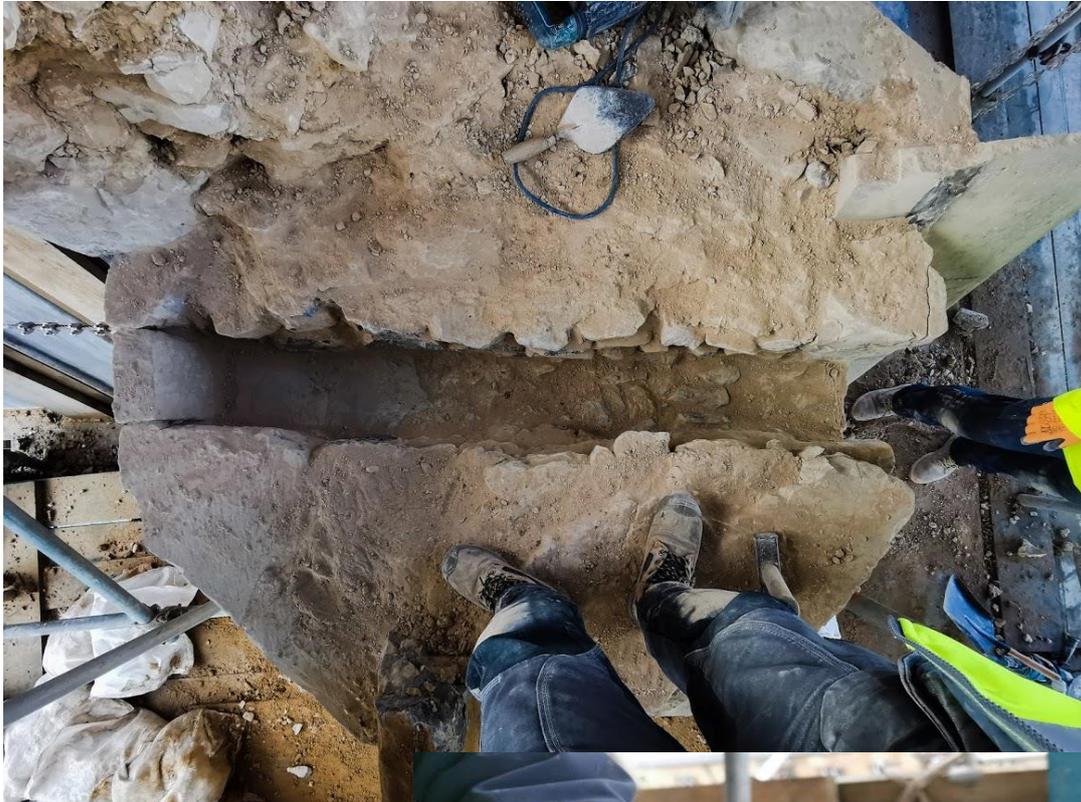
The putlog hole (see photo below) is a hole or channel usually found in medieval buildings in which a wooden beam or log would have been placed in order to support a scaffold. Very often they will have been filled in but this one was fully intact and lined with walling stones. A fantastic insight into the construction methods of our medieval colleagues!

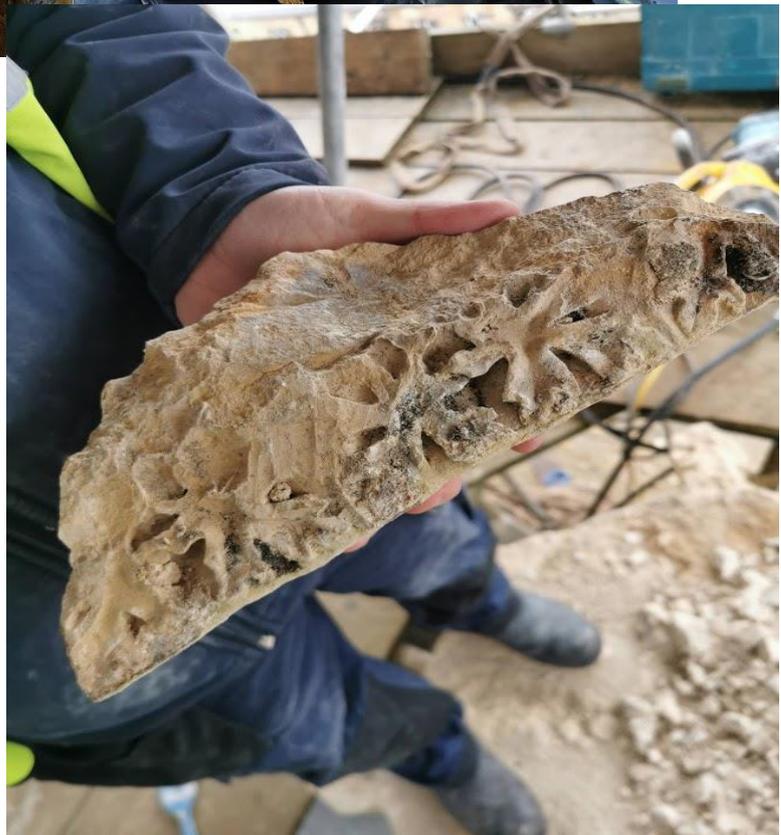
The second item we found buried in the 'infill' which makes up the core of the pinnacle. A small decorative carving featuring delicate flowers. The core of a solid structure like this will usually be filled with rubble and mortar, so to find a carving is very exciting; why was it discarded? We will never know.

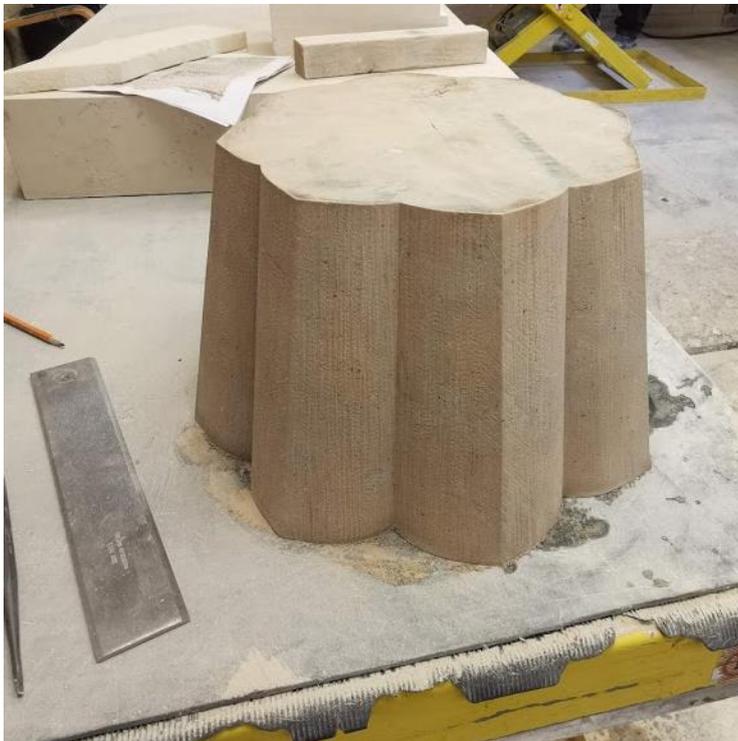
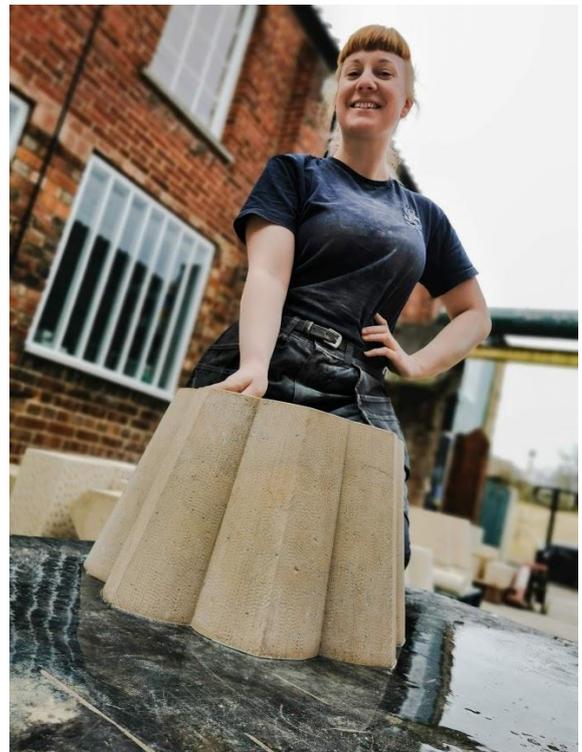
Over the course of a year all the new stones were worked and transported to site ready for hoisting and fixing, I was very lucky to be able to work the top roll mould and the finial to sit on the very top of the carving. See pictures below.

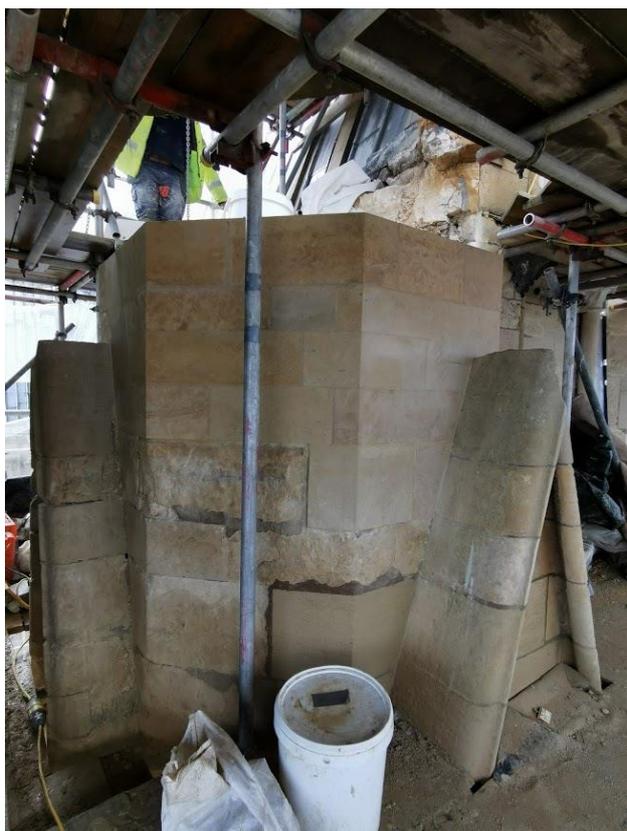
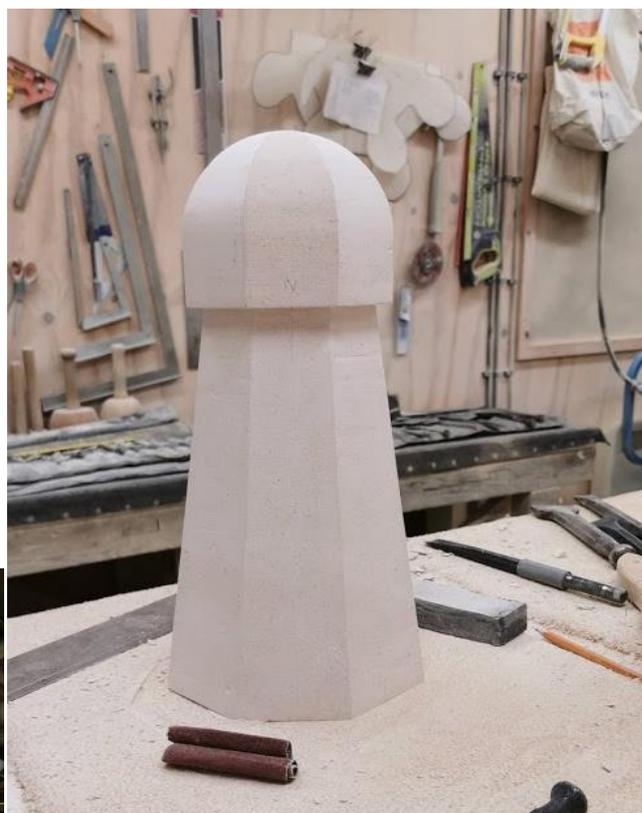
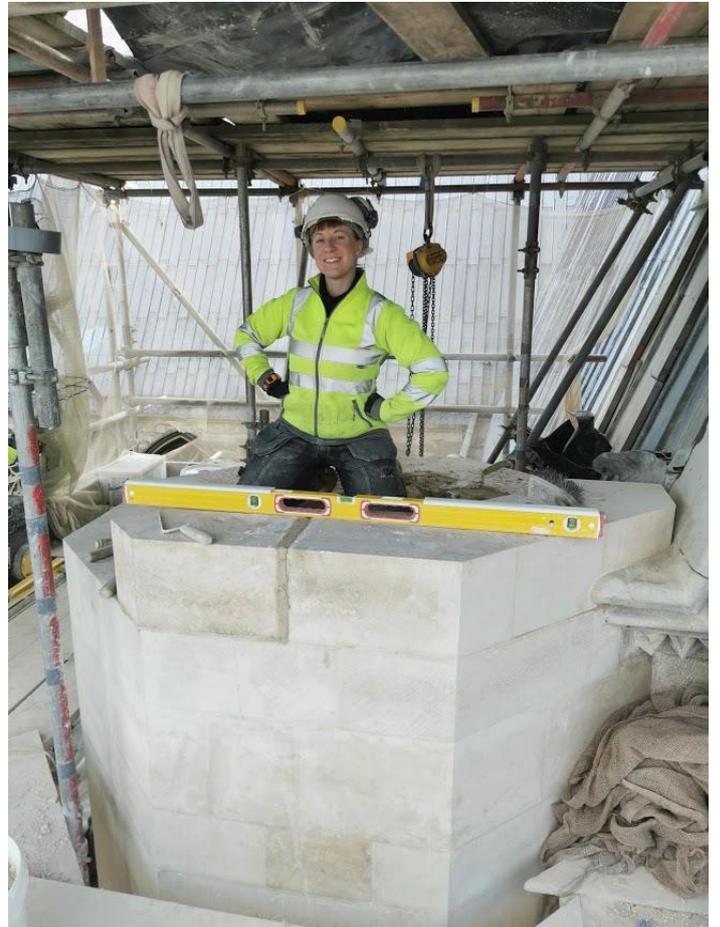
As with all building at the cathedral we use hot lime for the entire fixing process as the medieval masons would have and because it is a lot better for the longevity of the building.

As we build each course it is filled in with rubble and mortar to create a strong core at the centre.

(left + below) The ashlar courses being fixed.

In total we had 10 courses of ashlar that make up the octagon at the base of the pinnacle, one course called the string course on top of that to carry the water away from the building below it, then 14 courses of roll moulds on top of that getting increasingly smaller as they go up to form the point of the pinnacle. Then finally a carved decorative finial topped with the 'clowns hat' finial on the very top.

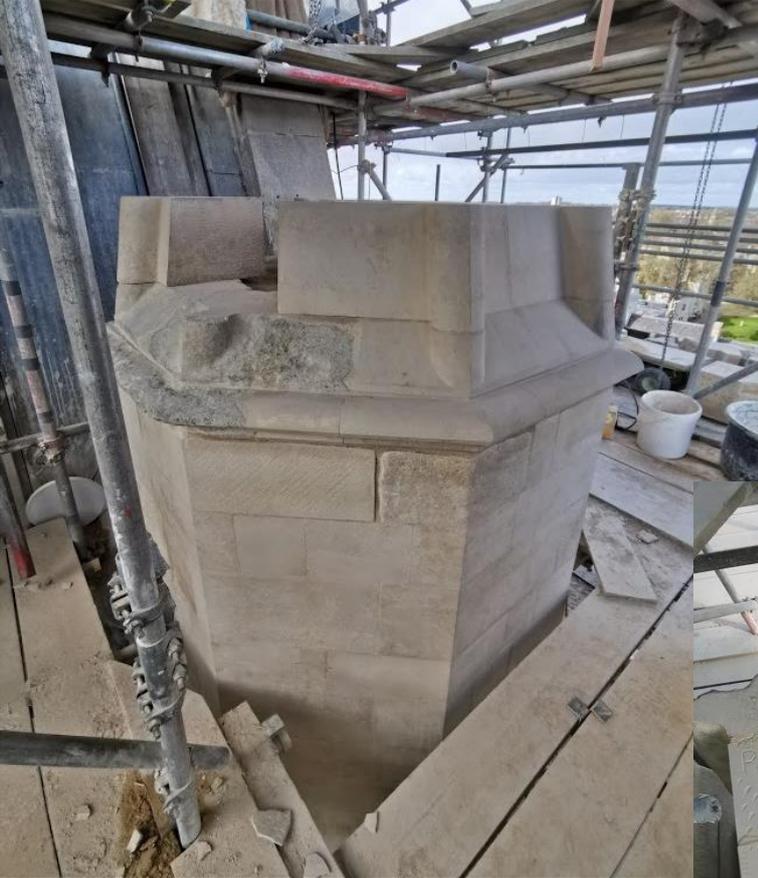
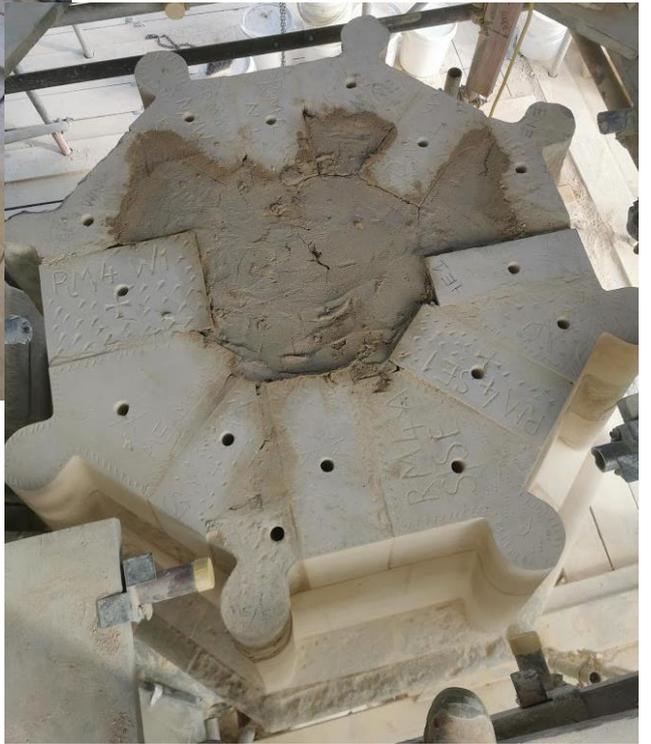
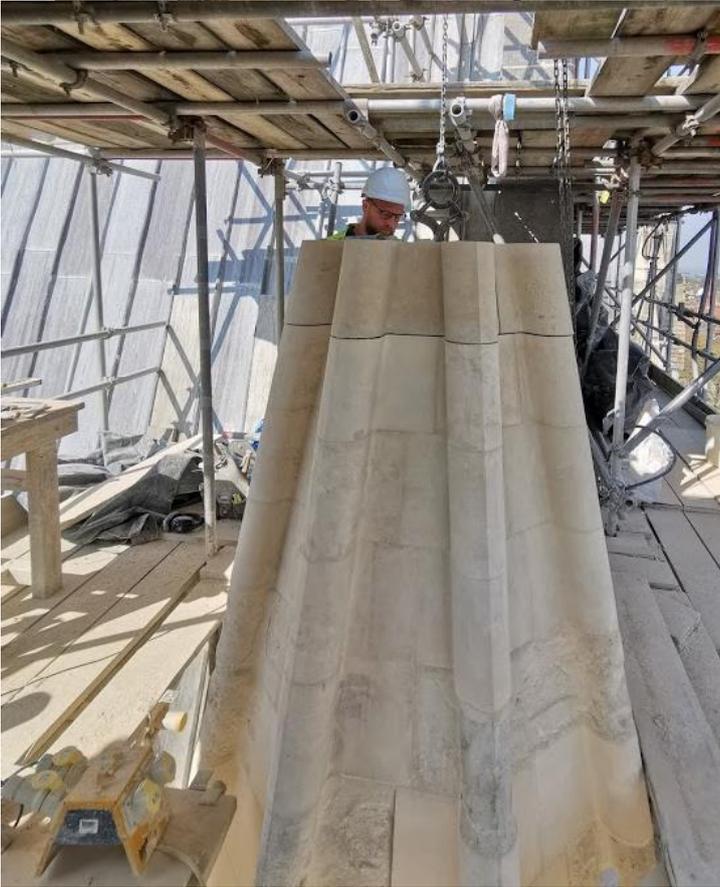
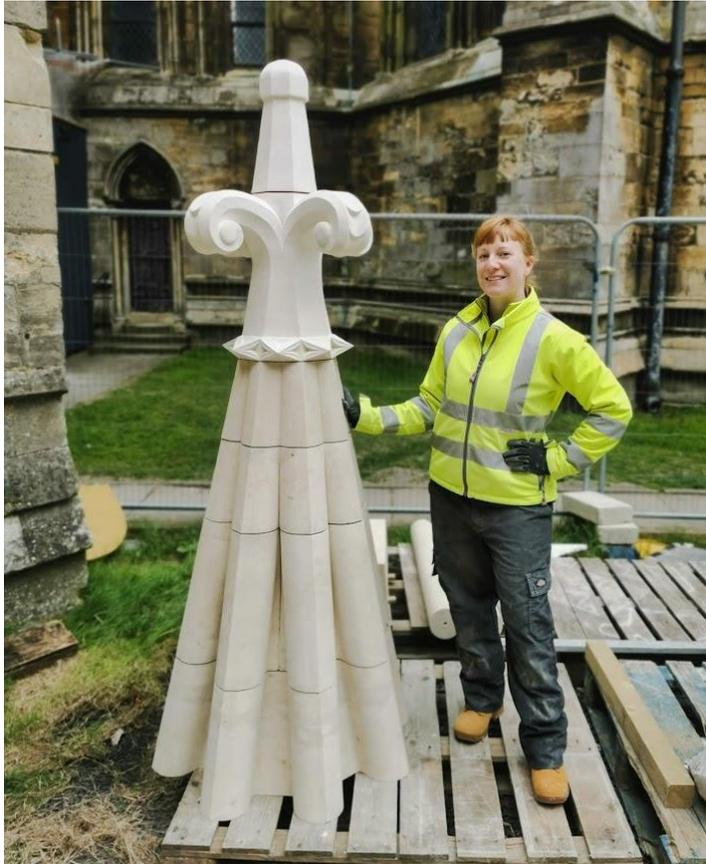
The string course sits on top of the ashlar and then the roll moulds carry the pinnacle up to a point.

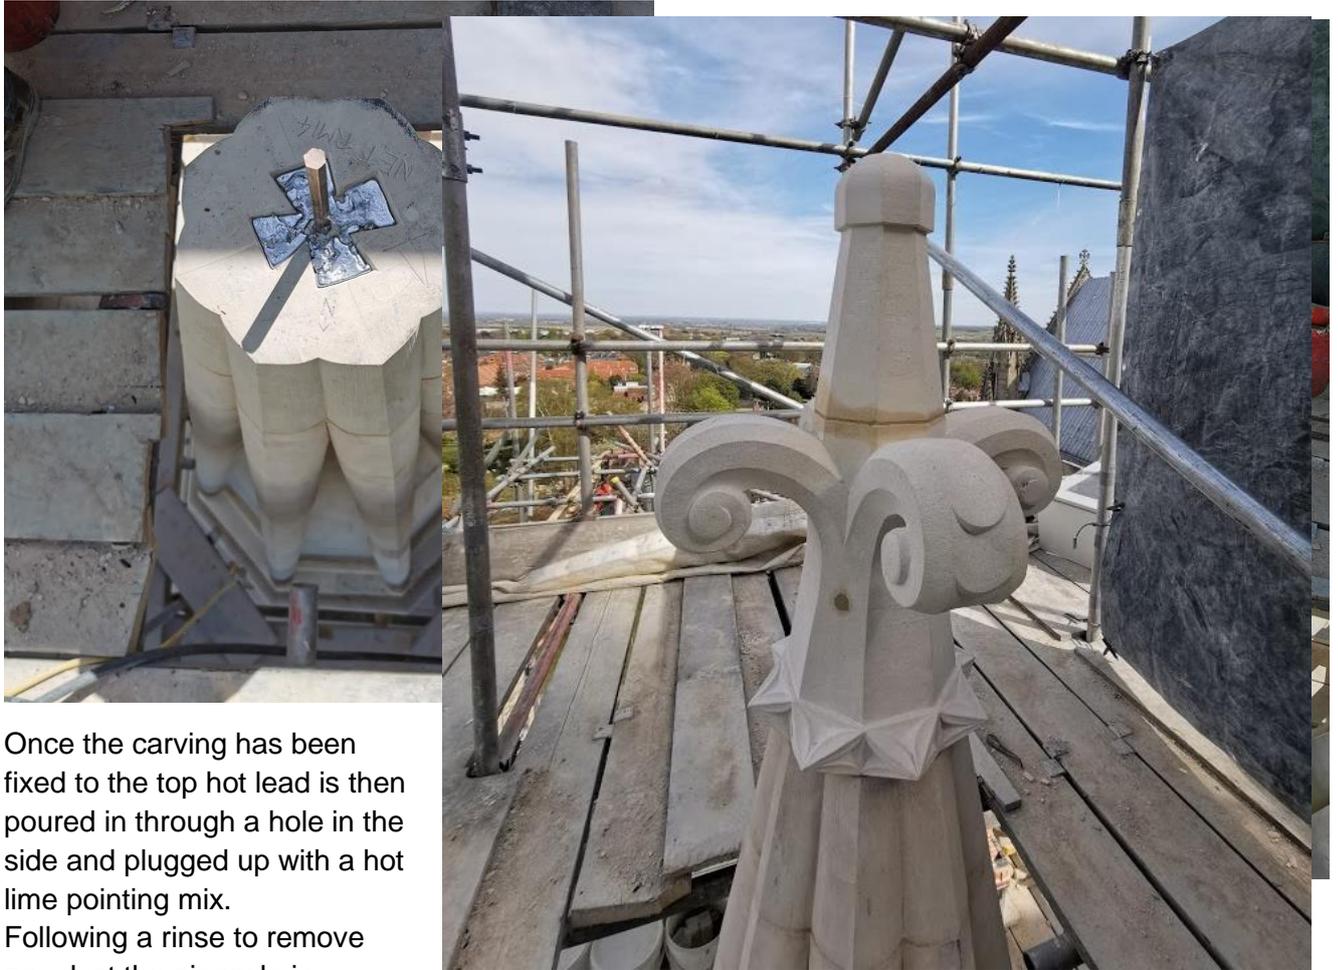
The final few courses along with the carvings we dry fixed at the bottom of the scaffolding to make sure everything lined up correctly before core drilling through the centre and cutting crosses known as joggles into the top and bottom of each stone.

The hole created by the core drill will take a phosphor bronze dowel all the way through from the top 3 courses of roll moulds to

the carved finial on top. As we fix each stone hot lead is poured in to lock each stone in place.

Once the carving has been fixed to the top hot lead is then poured in through a hole in the side and plugged up with a hot lime pointing mix. Following a rinse to remove any dust the pinnacle is finished.
