The Building of Hussey Tower

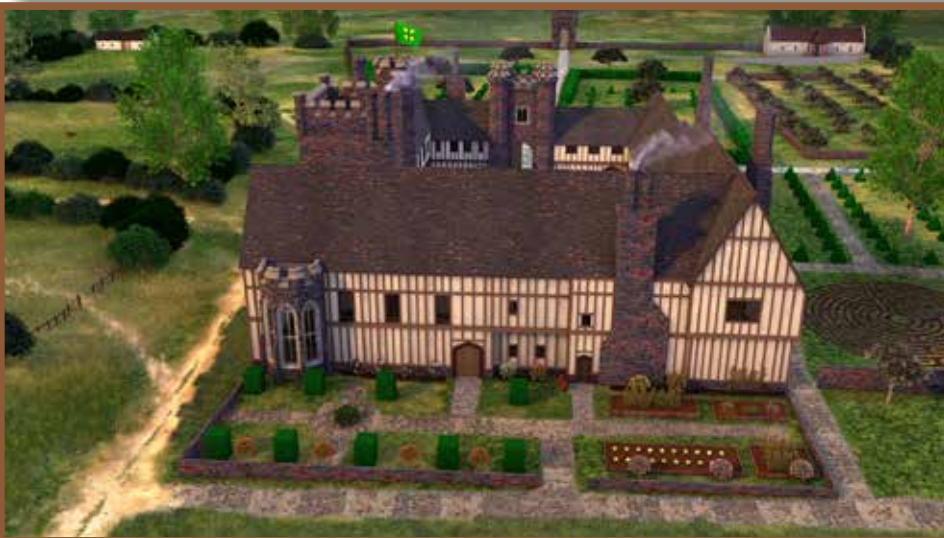
Computer-Generated Image (CGI) showing what Hussey Tower might have looked like in about 1500

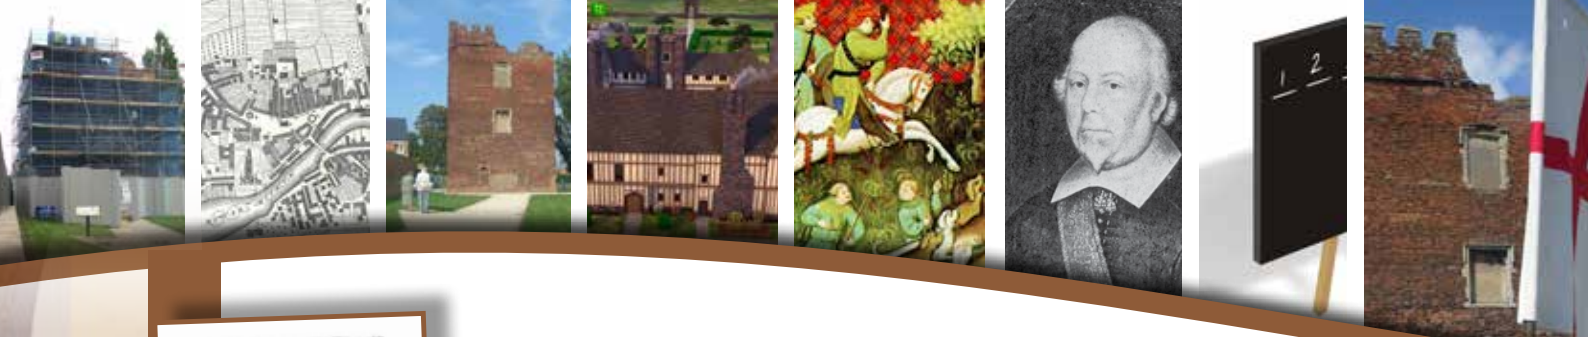
Brick bonds

English bond

Stretcher bond

English garden wall bond

Flemish bond

Header bond

The bricks that make up the tower were all hand-made locally. They are laid in a pattern called *English bond*. This is a very strong and expensive way of building. The bricks are

laid with their longest and shortest sides showing in alternate rows (courses). Most modern houses, including the ones next door to Hussey Tower, are built in *stretcher bond* with the bricks all laid with their longest sides showing. Other buildings in the town have their bricks laid in different ways.

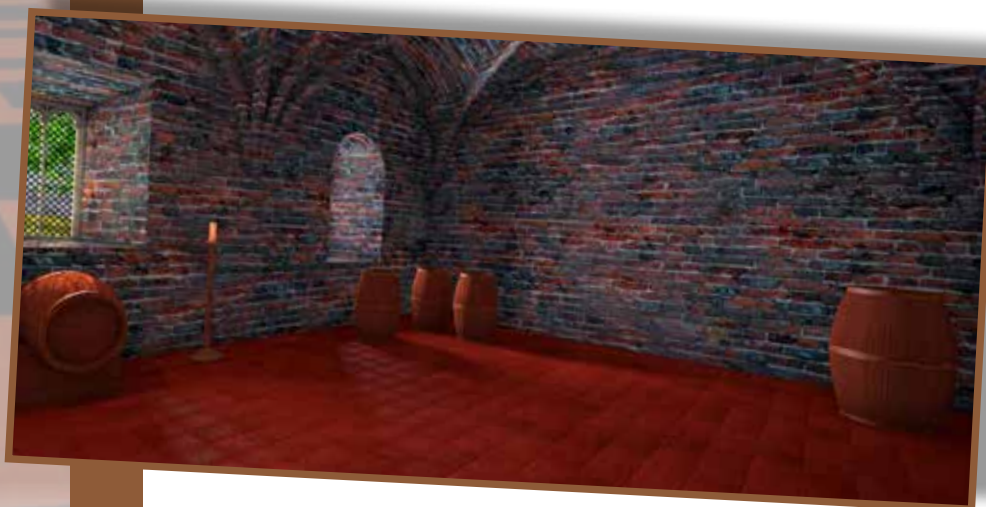
The vaulted ground floor room (undercroft) (CGI)

The ground floor room had a vaulted ceiling made of bricks. The vaulting was made up of two pairs of intersecting arched ribs side by side with a central arched rib between them. The spaces between the ribs were filled with brickwork. The remains of this vaulting can still be seen on the walls inside the tower). This room was most probably used as a service or store room.

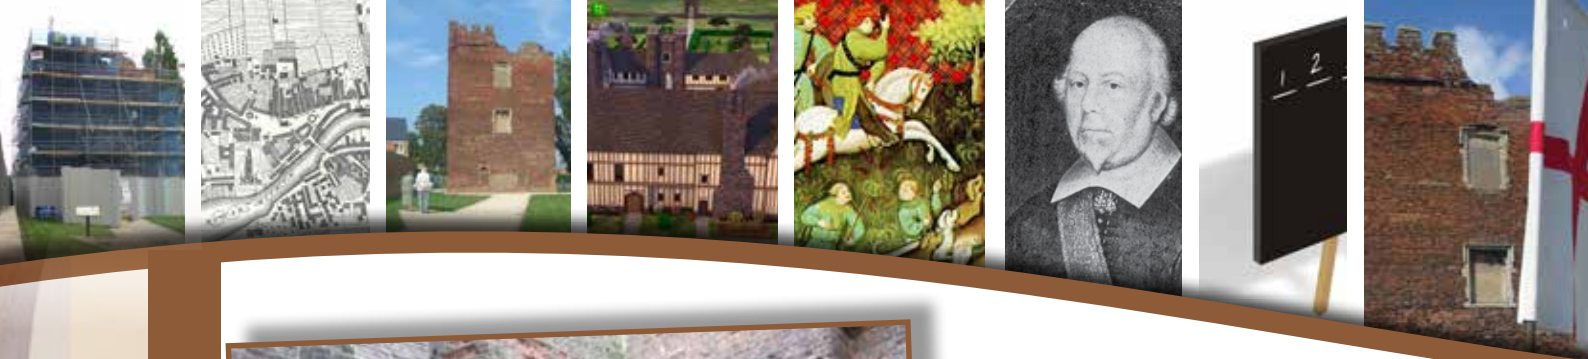
Vaulting remains

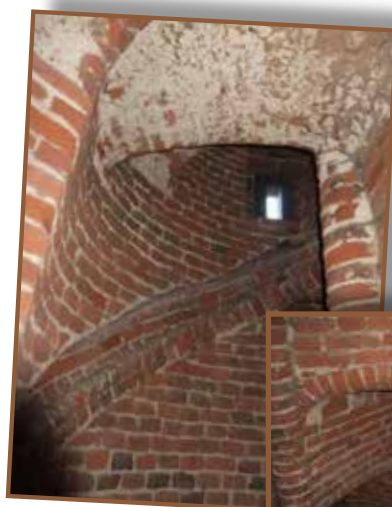
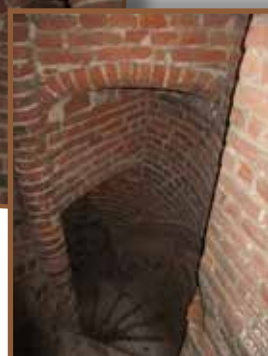
The staircase

The staircase, steps and handrail are all made out of brick. Some of the bricks were specially made and shaped to create certain

architectural features such as the handrail and the central newel (the vertical post that runs right up the middle of the staircase and supports all of the steps). The steps are supported on a series of arches that radiate off the central newel. The moulded handrail spirals all the way up the building.

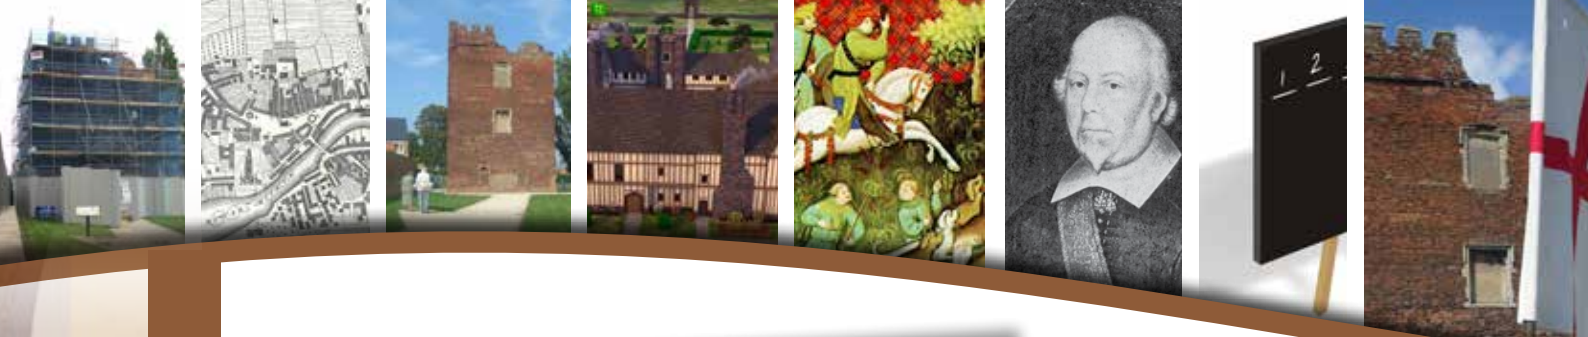
The top floor room (CGI)

The top floor room had a wooden floor. If you look at the inside of Hussey Tower you can see where the walls get slightly thinner at that stage to form the ledge that once supported it.

This room had two main windows and a fireplace. Another narrower opening looks out to the east towards the main doorway into the Great Hall. Could this have been for the Lord of the manor to keep an eye on the front door to see who was arriving and leaving? This upper room would have been the most important and private part of the house.

It would have been used as a sitting room, a bedroom and a private dining room. It would have been richly furnished with wall hangings and cushions.
