## What did Tupholme Abbey look like?

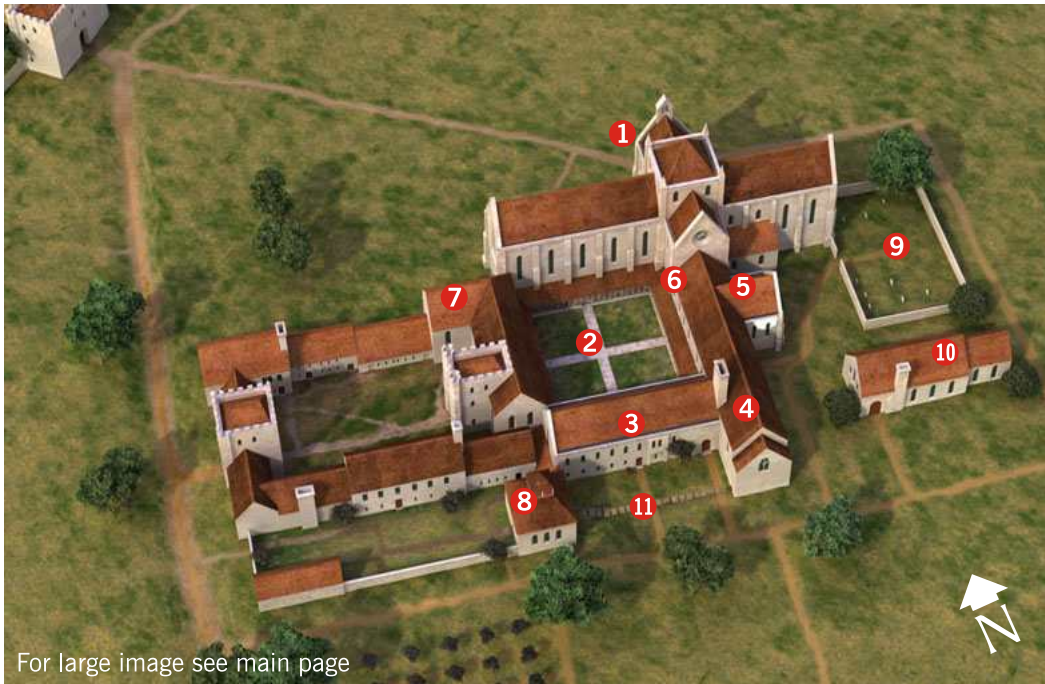
This is what we think the abbey might have looked like. How do we know this when there is so little still to see at Tupholme today?

**1** Abbey church made up of:  
**A)** Nave, **B)** Presbytery,  
**C)** Crossing (with tower over)  
**D)** North Transept  
**E)** South Transept  
**F)** Side Chapels  
**2** Cloister - The central area  
 with covered walkway around.

**3** Refectory range with storeroom on the  
 ground floor and the canons' dining  
 (refectory) upstairs.  
**4** Warming house on the ground floor with  
 the canons' sleeping accommodation  
 (dormitory) and toilet (reredorter) upstairs.  
**5** Chapter House where the canons held their  
 meetings to discuss the running of the abbey

**6** Night stairs  
**7** West range including  
 the Abbot's lodgings  
**8** Kitchen  
**9** Cemetery  
**10** Infirmary  
**11** Drain

But we have to remember that the picture we end up with may not be accurate because a lot of the pieces are missing and we have to try to fill in the gaps as best we can. We also have to remember that the abbey was in existence for around 370 years and the original buildings were probably altered and added to over that time. The reconstruction shows what Tupholme might have looked like in about 1390.

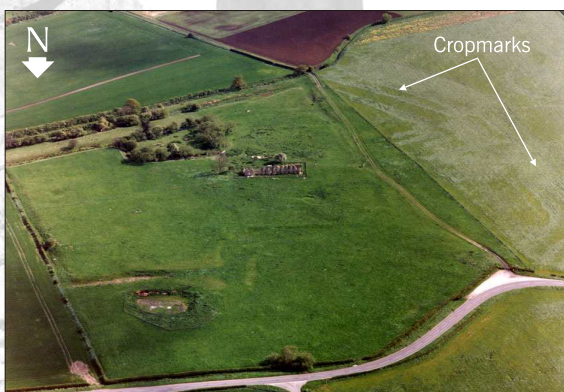
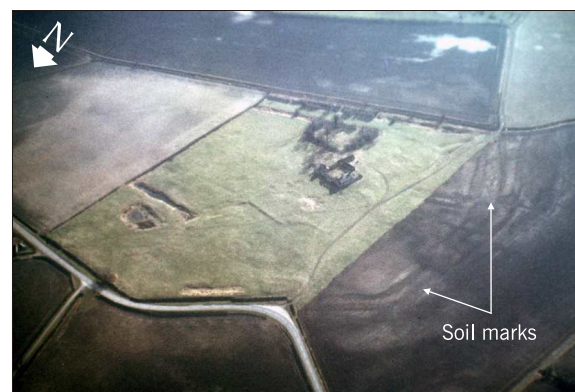
On the west side, however, we know that the precinct went further than the present field boundary. By looking at aerial photographs we can tell that it extended into the arable field to the west. As we can see, these two photographs were taken at different times. In one of the photographs the field has been ploughed and in the other it has a crop growing in it. The edge of the precinct shows up as different colours in the ploughed soil, and also in the growing crops.

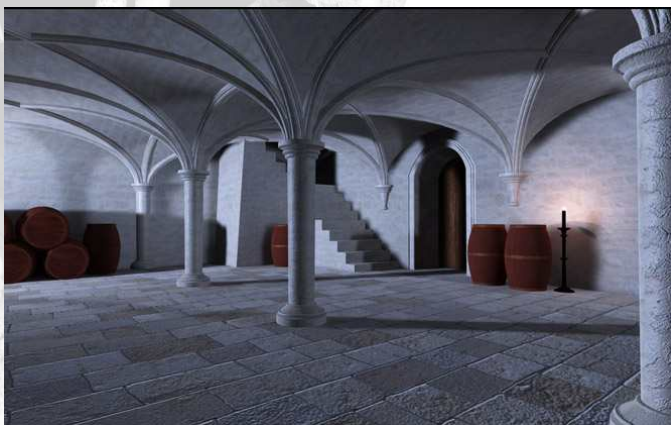
The downstairs storeroom of the range (**the undercroft**) had a vaulted ceiling. A vaulted ceiling is one that is supported on arches. The style of vaulting used at Topholme is called **quadripartite rib vaulting**. This computer-generated picture shows how the undercroft would have been divided into sections (bays) with each bay having pairs of diagonal arches (ribs) supported by columns. The ribs divided each bay into four sections. We know this

because the remains of the vaulting can still be seen on the north side of the wall, and Samuel Buck's 1726 engraving of the abbey gives a glimpse of one of the columns through the south door of the range.

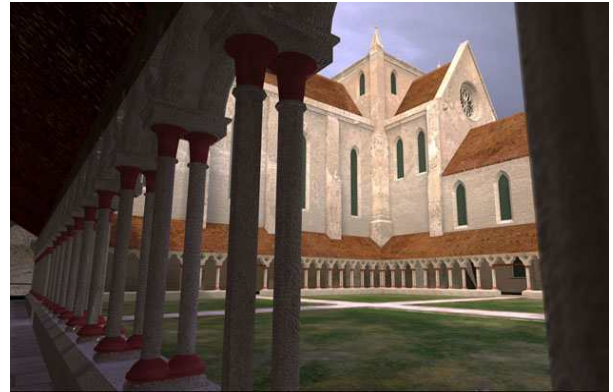
The cloister formed an open space or garden in the middle of the abbey buildings. It would have had a roofed walkway around its perimeter. If we are right in thinking that the pieces of stone that are now in the reader's pulpit came from the original cloister, we can put them back into position to help us reconstruct the cloister. But reconstructing the other abbey buildings is not quite as straightforward. We have to look for other clues to help us.

Computer-generated image of the cloister

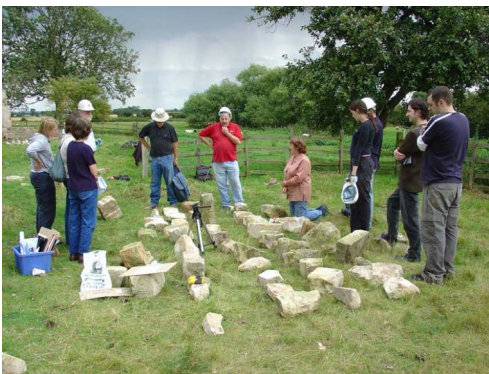
Studying the abbey stones

Because the refectory wall is made of stone we can be fairly certain that most of the other main abbey buildings would have been as well. We know from looking at the refectory wall that the stone was quarried locally. When the abbey was gradually demolished after the Reformation, some of the stone was reused and has remained on the site until today. Many of the remaining stones were pieces that had been carved to build particular features of the abbey. A project was recently carried out to gather together all the loose stones at Topholme, and to record the information that could be discovered from them.

Nearly all the stones studied were of the same local oolitic limestone that was used to build the refectory wall, but there were two very large carved stones that were made of a different type of limestone called Lower Magnesian Limestone that is found in Yorkshire.
